## Loadbreak Bushing Inserts Missing Ground (Drain) Wires

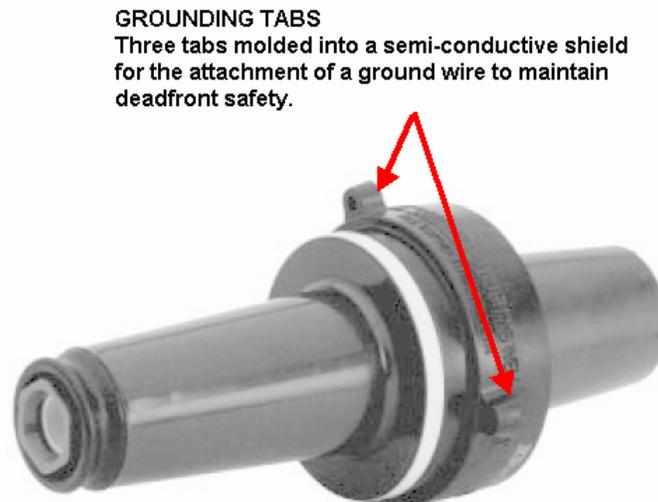
**Figure 1 – Loadbreak Bushing Insert**

**Background Information** – The bushing drain-wire requirement only applies to transformers or switchgear with bushing inserts (Figure 1). Bushing inserts are field replaceable and screw into bushing wells installed in the equipment.

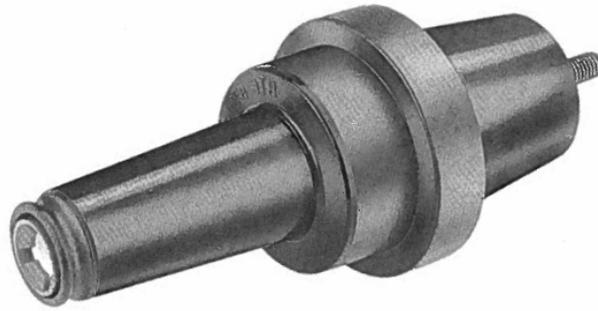
**Figure 2 – Integral Loadbreak Bushing  
(Does not have grounding tabs)**

If the equipment has integral bushings, then the drain-wires are not needed (Figure 2). Integral bushings are one-piece, non-field replaceable.

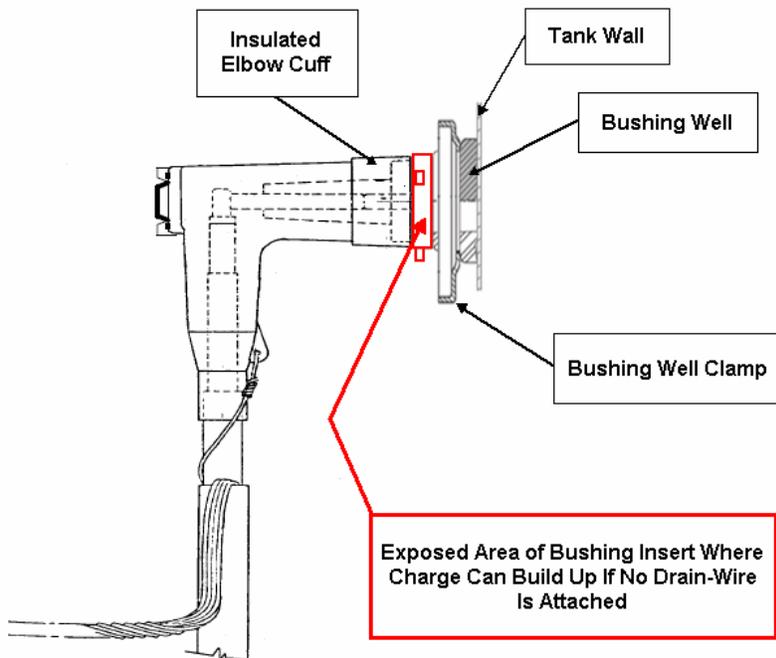
Provided that the loadbreak elbow or insulating cap has their ground tabs connected to ground with a drain-wire, the exposure to this static discharge hazard is minimal. The bushing well is bonded to the tank wall; the bushing well clamp is bonded to the tank wall; and the elbow connector cuff covers most of the bushing insert. With this in mind, the area of exposure for an ungrounded bushing insert is shown in Figure 3.

**Figure 3 – Portion of Ungrounded Bushing Insert  
That May Develop a Static Charge**

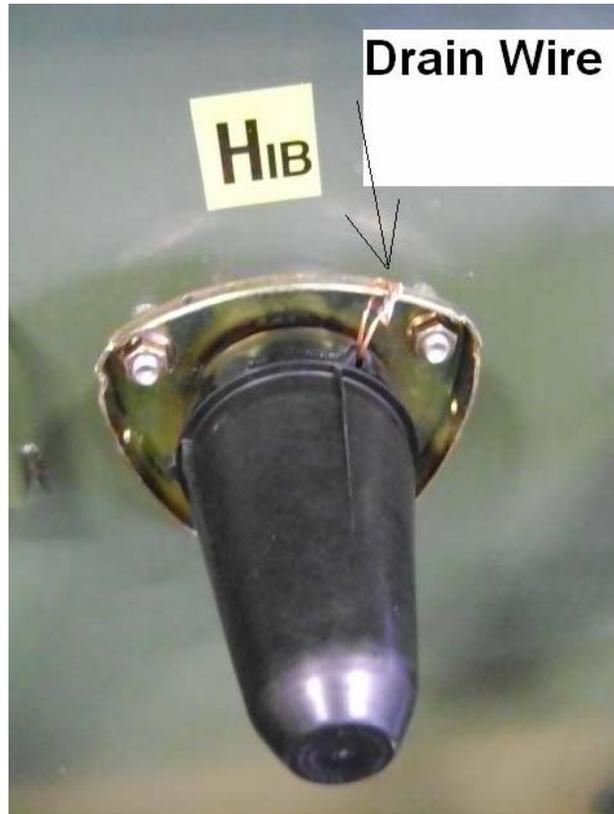
Figure 4 –Bushing Insert Properly Grounded with a Drain-Wire

The following picture (Figure 4) shows a bushing insert properly grounded with a drain-wire. A piece of concentric neutral wire from the cable may be used to make the drain wire.
